Manhole Inspection Summary

Manhole # S11O__025MH

Inspection ☐ Is Incomplete Rating: **4) Poor**

Location Address: **3221 Stafford St**

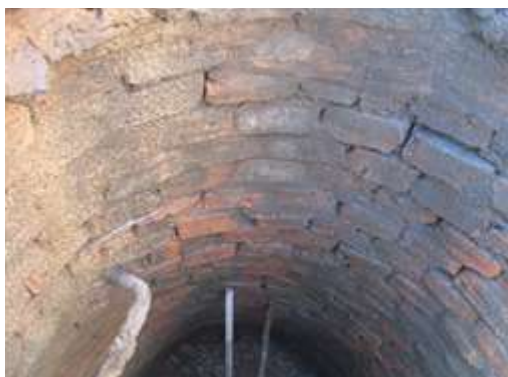
Defect 2

Condition: ☐ Sound ☐ Cracked ☐ Root Intrusion ☒ **Loose Brick** ☐ Deteriorated

loose bricks and mortar along corbel wall/evidence of corbel and barrel infiltration

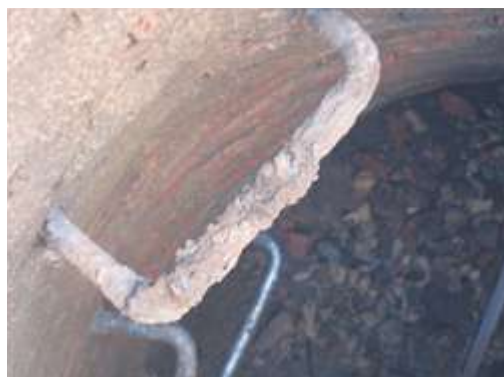
Defect 1

Count: **3** Missing: **0** ☒ **Corroded**

corroded steps

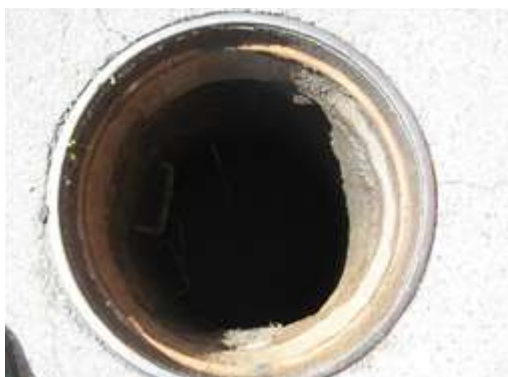
Defect 3

☒ **Leaks**

frame leaks

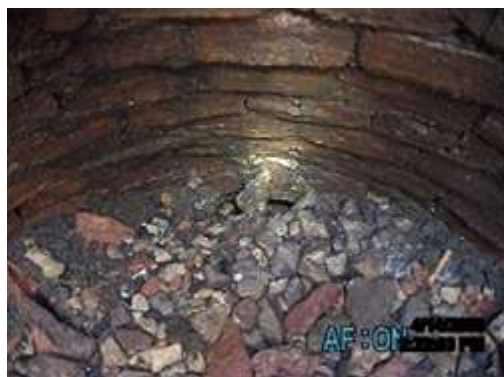
Defect 4

Condition: ☐ Sound ☐ Cracked ☐ Root Intrusion ☐ Deteriorated ☐ Leaks ☒ **Debris**

channel debris

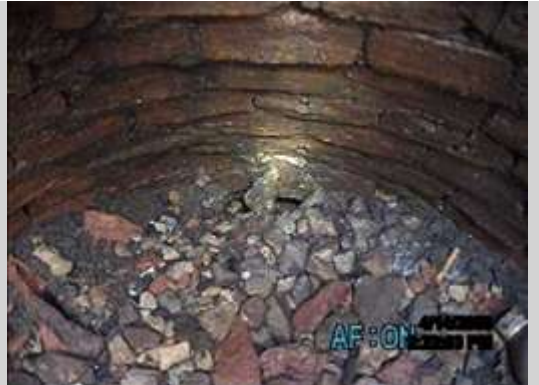
12 O'Clock Outflow

Deposits: ☐ None ☐ Mud ☐ Sludge ☒ **Debris** ☐ Grease

Silt Depth: **5** (in.) Deposits Extent: **Heavy**
